Peak Gold Mines
MONTHLY ENVIRONMENTAL MONITORING SUMMARY
REPORT

EPL 3596
Hillston Road, Cobar
NSW 2835

September 2021

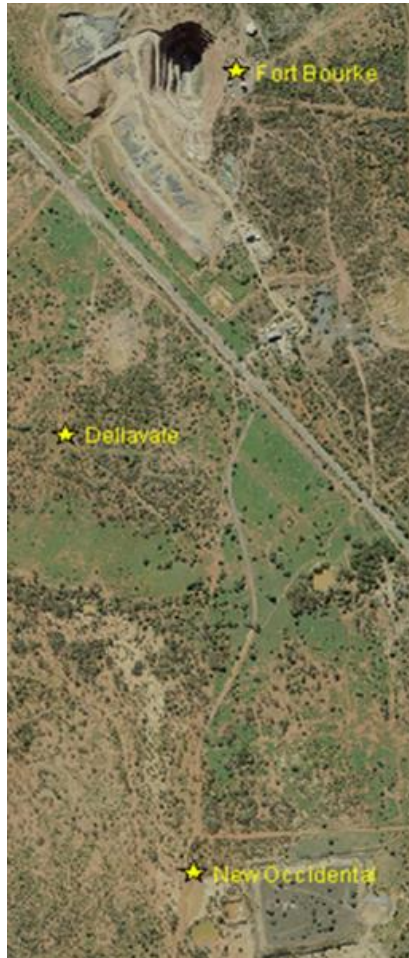
Figure 1: Location of Vibration Monitors on PGM's Mining Leases.

The vibration monitoring results displayed in Table 4.1a represents all blast vibration events that were triggered at the New Occidental, Fort Bourke and/or Dellavale monitors (Figure 1).

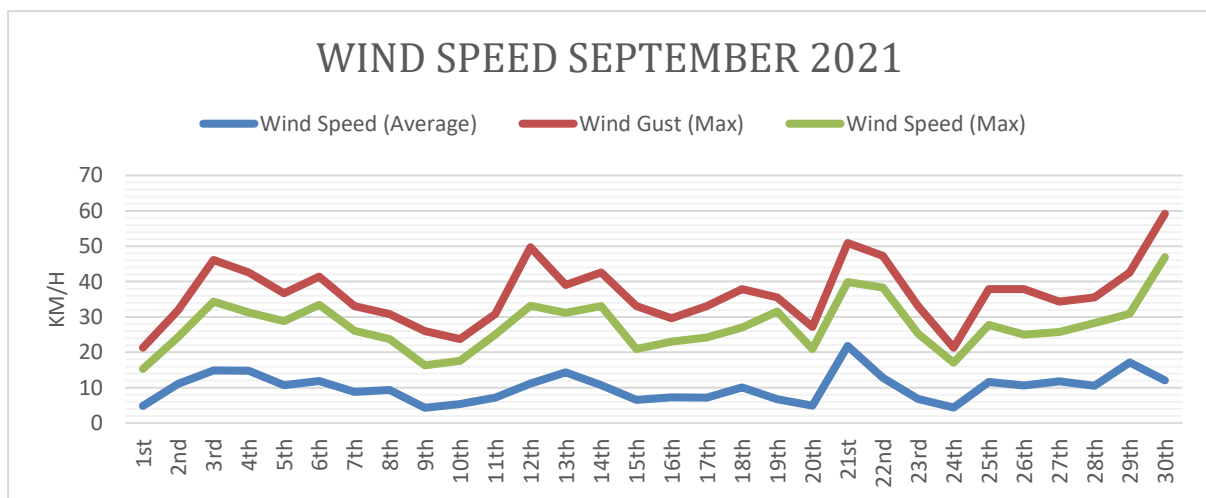
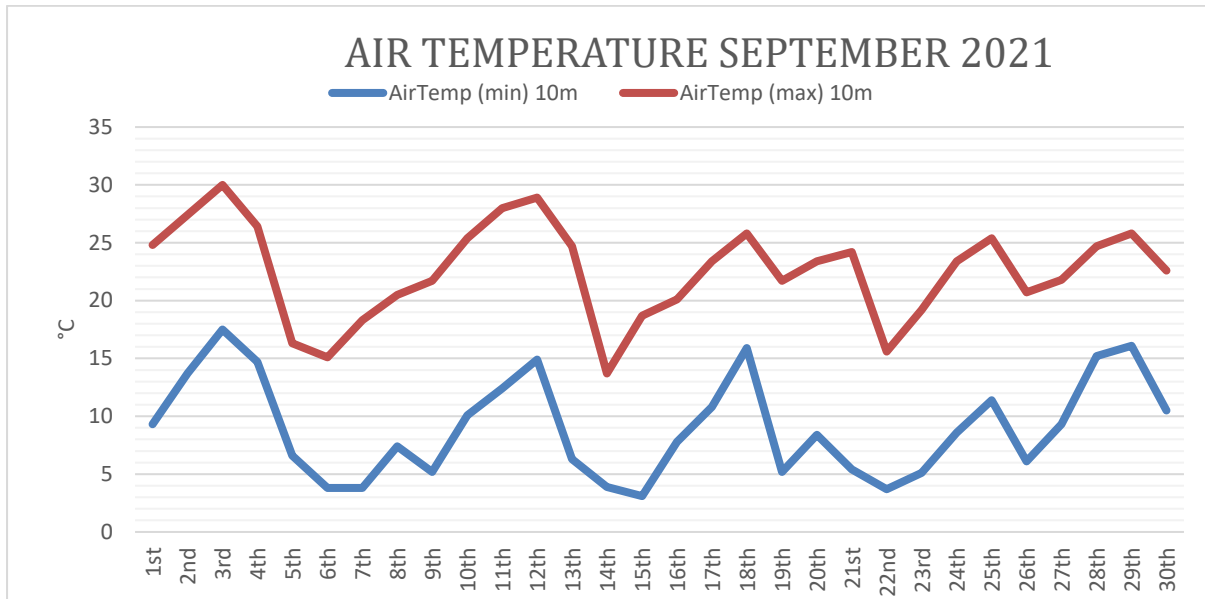
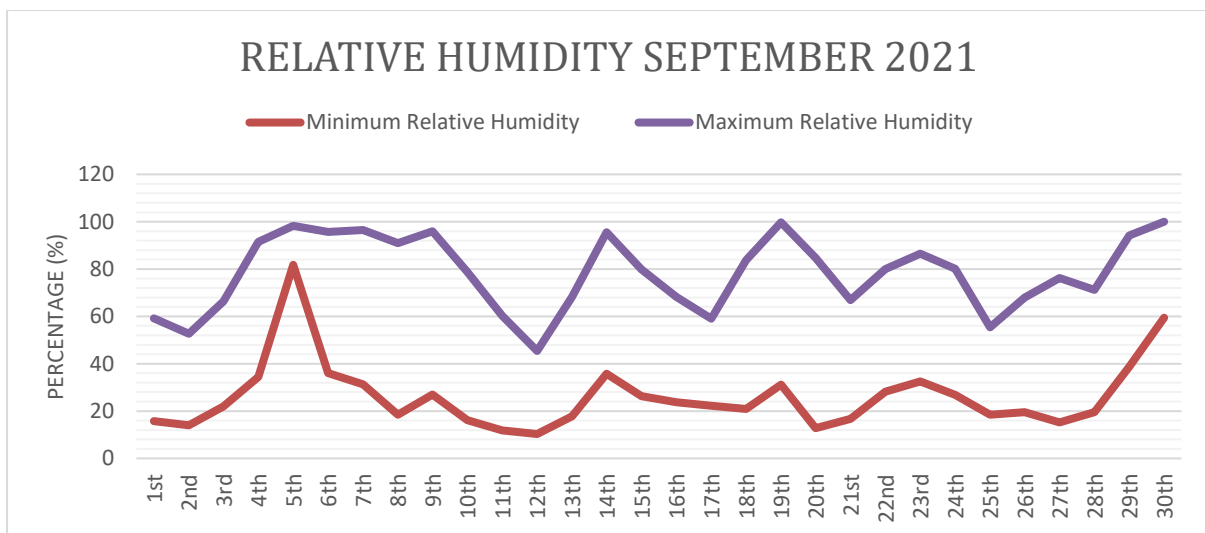
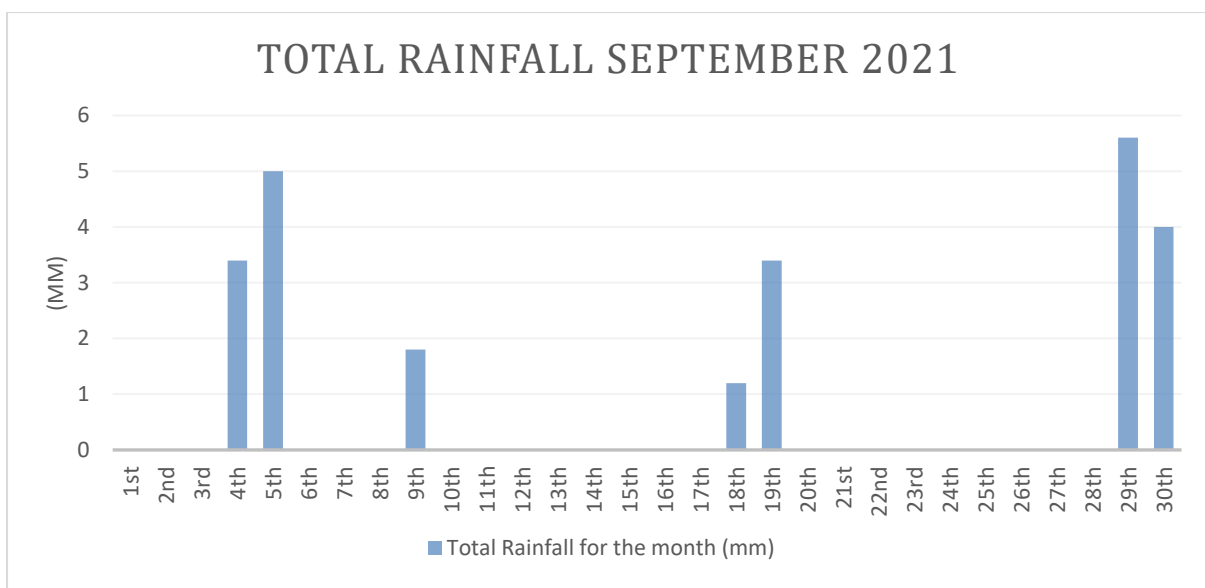
The meteorology monitoring data is acquired through PGM’s weather station located 2km South of Cobar.
