Dargues Gold Mine Aquatic Ecology Monitoring Autumn 2023

Draft report to the Aurelia Metals Ltd
Centre for Applied Water Science
University of Canberra

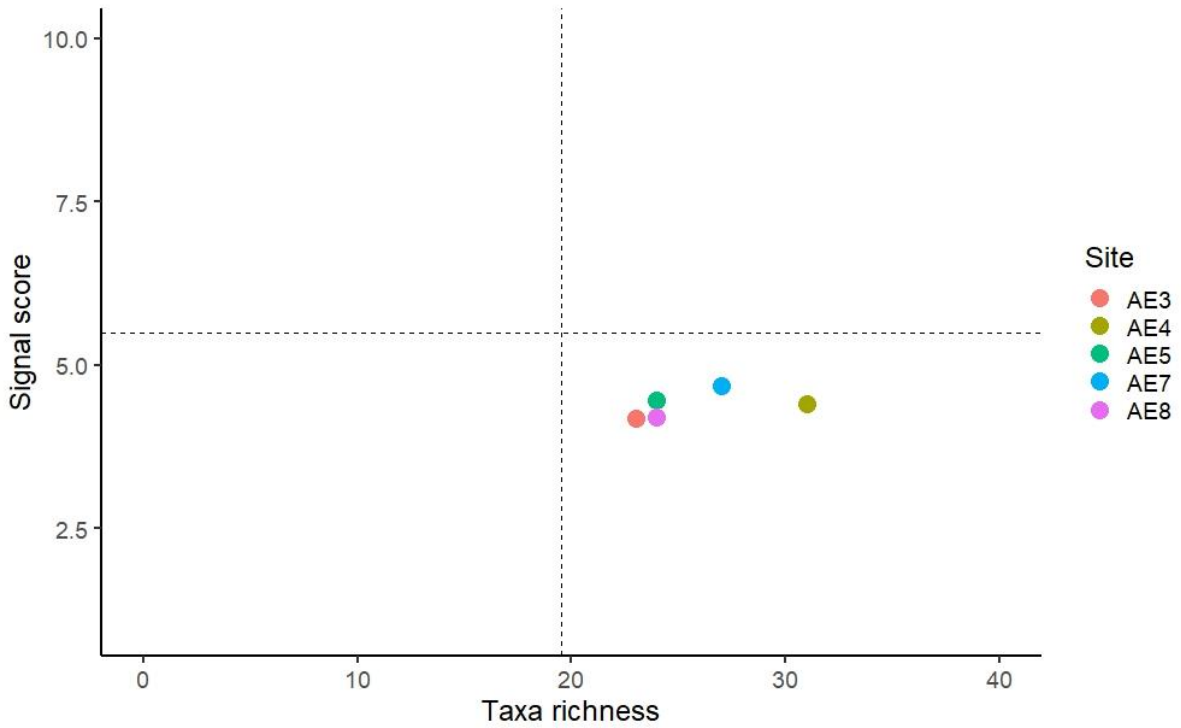
Figure 3. Biplot of macroinvertebrate communities collected from edge samples. Dotted lines indicate the location of quadrants for interpretation of site SIGNAL results (from Chessman 2001).

The average SIGNAL scores for each site ranged from 4.23 at AE4 to 6.31 at AE1 in autumn 2023 (Table 5). AE4 had the lowest SIGNAL score and AE8 had the lowest proportion of sensitive taxa (Table 5). For edge communities, SIGNAL scores at reference sites were 4.50 – 4.70, indicating moderate pollution. For the impacted sites (AE3 – AE5) the average SIGNAL was between 4.23 – 4.38 for edge communities, indicating moderate pollution. Riffle habitats had higher SIGNAL averages than edge habitats with scores ranging from 5.58 – 6.31 (Table 5). All sites where edge samples were collected had similar site SIGNAL scores, although they varied a little in the number of taxa, were all assessed as being in the same condition quadrant (Quadrant 2: community impairment, often caused by high salinity or nutrient levels) (Figure 3). There was no significant difference in the macroinvertebrate communities between sites upstream of the mine and sites downstream of the mine, based on samples collected from edge habitats (Global R = 0.1667, $p = 0.500$) (Figure 4).

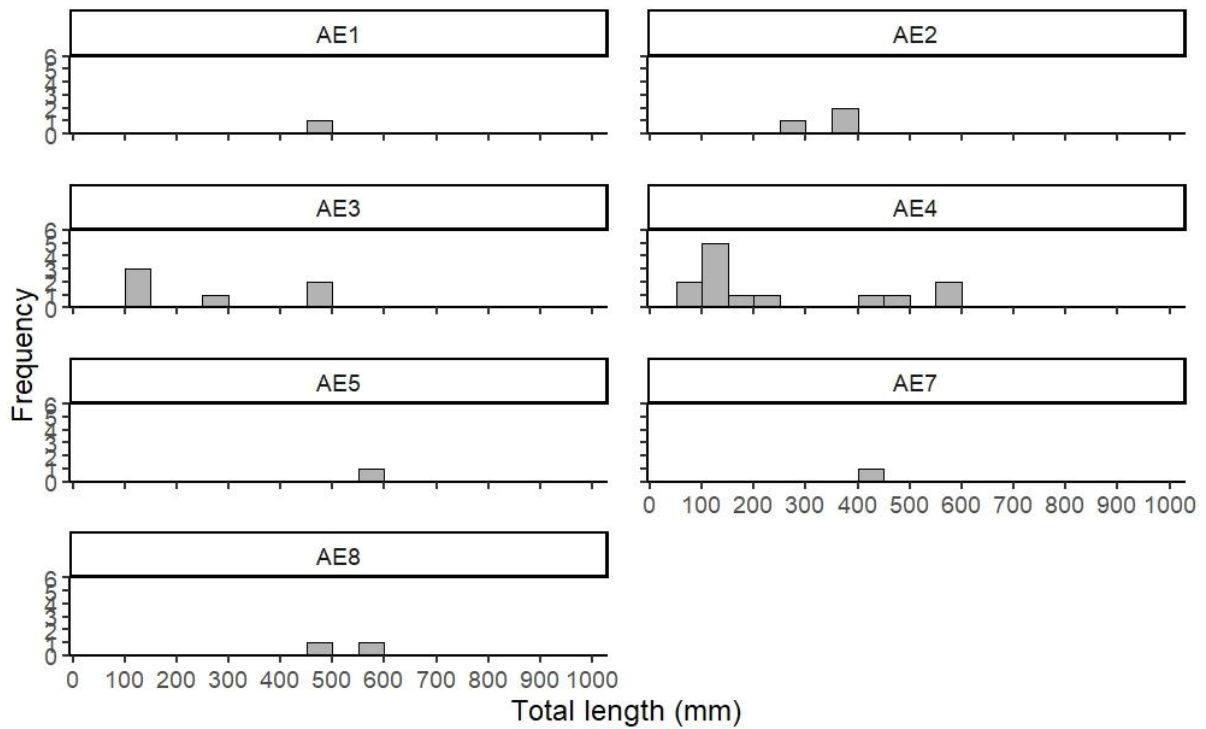
Figure 5. Length frequency of Short-finned eel captured by backpack electrofishing at all sites in autumn 2023.

The most widespread species was Short-finned eels with 27 individuals captured across all sites, except AE6, and ranging in size from 100 – 600 mm total length (TL) (Table 7 and Figure 5). Two Long-finned eels were captured, one at each site AE1 and AE2, measuring 500 and 335 mm (TL), respectively (Table 7). Mountain galaxias were the most abundant species with 243 individuals (comprising 53 % of total number of fish captured) captured across five sites ranging in size from 34 – 94 mm fork length (FL) (Table 7 and Figure 6). Of this total 30 fish were caught in bait traps at site AE7 and one individual at AE8. A total of 94 Cox's gudgeon were caught at sites AE1 and AE2 and ranged in size from 37 – 116 mm (TL) (Table 7 and Figure 7). A total of 74 Australian smelt were

The highest catch rate for Short-finned eels occurred at site AE4 with 78 fish per hour (Table 8). Catch rates for Mountain galaxias were the highest at site AE8 with 469 fish caught per hour followed by AE7 with 366 fish caught per hour (Table 8). The most common size range was between 50 – 70 mm (FL) (Figure 6). Site AE2 had the highest catch rate for Cox’s gudgeon and Australian smelt with 330 and 348 fish caught per hour, respectively (Table 8, Figure 7 and Figure 8). The most common size range was between 40 – 70 mm (TL) for Cox’s gudgeon and 50 – 60 mm for Australian smelt (Figure 7 and Figure 8).

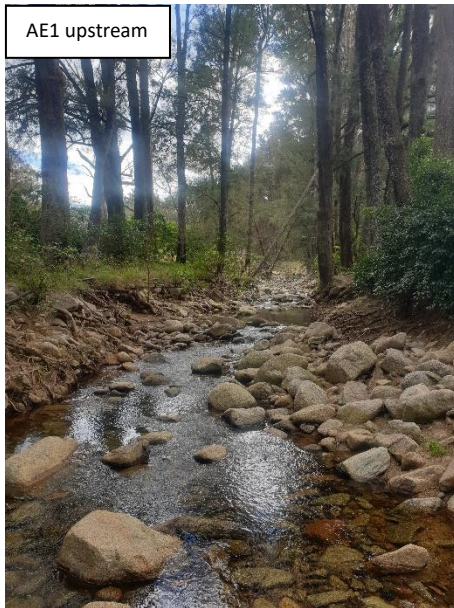
Site AE1

This site is 5 km downstream of Dargues gold mine near Araluen. It is sparsely vegetated with both native and exotic species.

The channel bed consists of cobbles and boulders embedded in sand and gravel. The water was slightly turbid at the time of sampling due to rainfall the previous night. Riffles were present linking the pools. The pools seemed to be shallow due to flood events washing in sand and gravel.

The trees and shrubs in the riparian corridor along the stream were mostly native with casuarina being the dominant species.

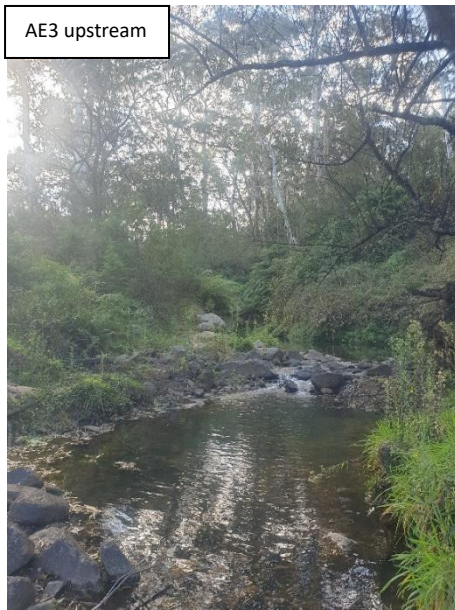
Site AE3

This site is on Majors Creek, 300 m from the top of Majors Creek Falls and 900 m downstream from the mine. The riparian zone consisted of a mix of native and exotic species while the broader area outside of this was mostly undisturbed native vegetation.

The channel frequently alternated between riffles and pools and consisted of bedrock with cobbles and boulders. Bars of sand and silt were common, and the bottom was heavily silted. Bank undercutting was frequent along the stream and the banks were mainly held by ferns and grasses.

The water was turbid at the time of sampling due to recent rainfall. No macrophytes or algae was present at the time of sampling.

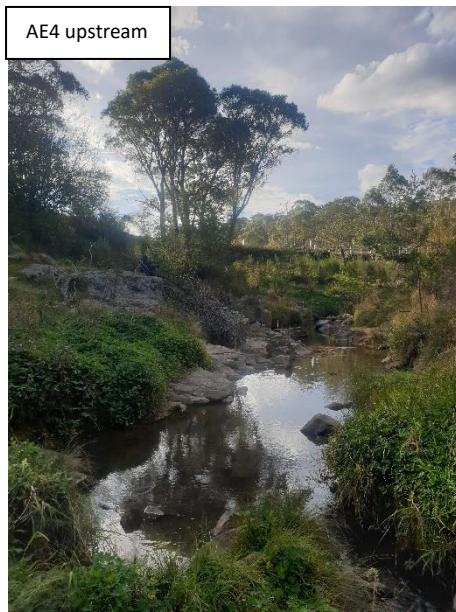
Site AE4

This site is 400m downstream of Majors Creek Road. The riparian zone consisted of mixed native and exotic trees and shrubs while the broader area consisted mixed native vegetation, pastures and exotics.

The channel consisted of long pools and runs with infrequent riffles. Many large boulders were present and bars of sand and silt were common and the bottom was mainly loose with fine detritus mixed with sediment. Bank undercutting was frequent along the stream the banks were held by grasses and sedges.

The water was turbid at the time of sampling due to recent rainfall. No macrophytes or algae was present at the time of sampling.

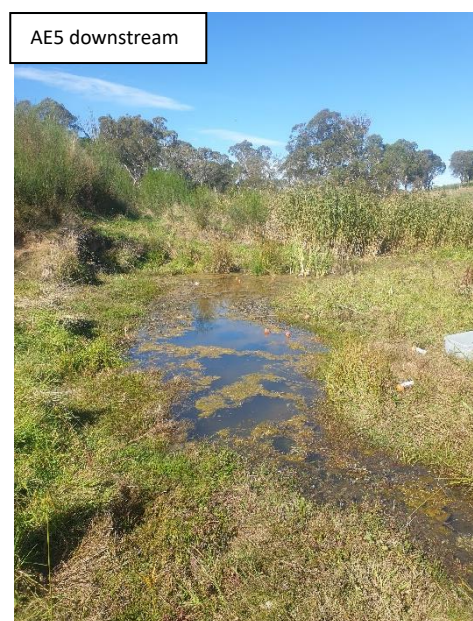
Site AE5

This site is on Spring Creek and downstream of Dargues goldmine project area. The riparian zone is made of mostly grasses and herbs (exotic and native) which supported both banks. The broader area consisted of mainly pasture with scattered trees.

The channel consists of narrow runs and occasional pools. The creek bed consists of cobbles and boulders with bars of sand and silt common. Bank undercutting was frequent along all parts of the creek.

The water at the time of sampling was clear. Submerged and emergent macrophytes were present within the reach with some algae present also.

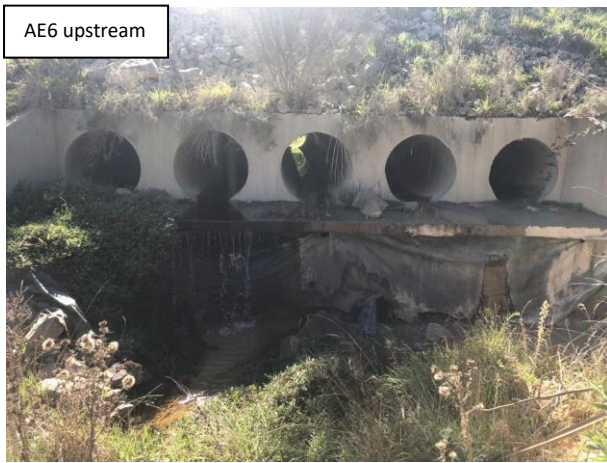
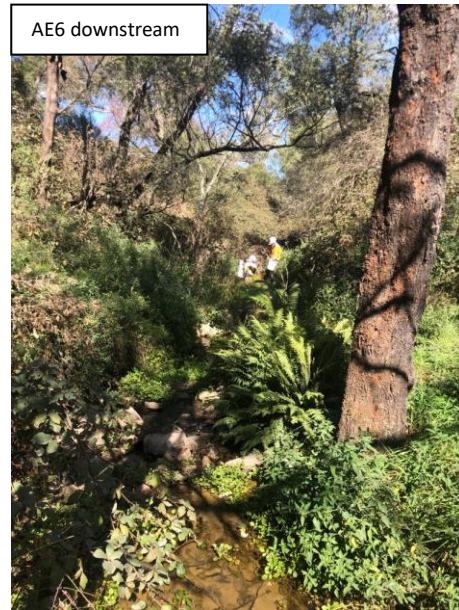
Site AE6

This site is on Spring Creek upstream of Dargues gold mine and approximately 700m upstream of AE4. The survey area is immediately downstream of the haul road crossing. The riparian zone consisted of pasture grasses and with minimal trees and was overgrown with blackberries.

The channel consists of narrow runs and occasional pools. Cobbles and boulders were present with the benthic composition being sand and silt.

The water at the time of sampling was clear. Submerged and emergent macrophytes were present within the reach with some algae present also.

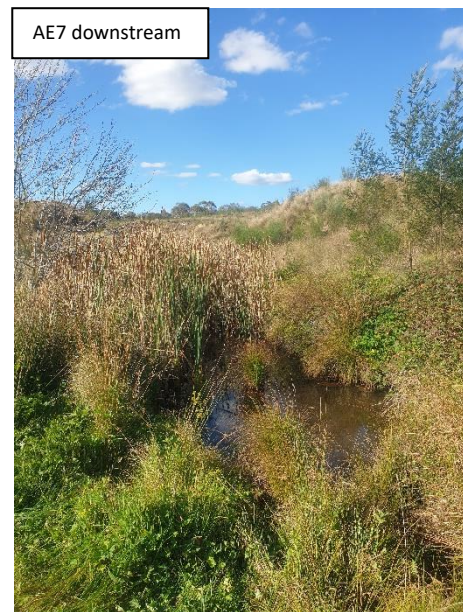
Site AE7

This site is on Majors Creek approximately 1 km upstream from the confluence with Spring Creek. As it is upstream of the gold mine it acts as a reference site as there are no potential influences from the mine. The riparian zone consisted of shrubs and grasses that overhung the water on both banks with no mature trees present. The vegetation in the broader area was similar to the riparian zone.

The channel consisted of runs and pools with no riffles. The creek bed consisted of sand and silt with boulders and shallow bedrock.

The water was clear at the time of sampling. Woody debris was common throughout the reach and the pool upstream of the weir was dominated by emergent macrophytes.

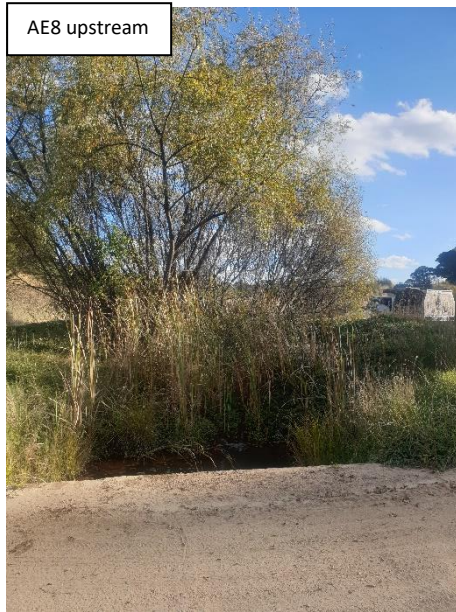
Site AE8

This site is on Majors Creek, north of the Majors Creek village and is divided by a road causeway. Like AE7 it acts as a reference site as its upstream of any potential impacts from the mine. The riparian zone was dominated by exotic trees and shrubs in particular willows and blackberries. The broader area has been cleared and consisted mostly of grasses.

The channel consisted of a pool upstream of the causeway and shallow runs downstream. The creek bed consisted of soft sediment and some woody debris consisting of fallen willow and willow roots.

The water was turbid and iron flocs occurred on the edges of the creek. The pool upstream was heavily lined with emergent macrophytes and downstream was choked with juvenile willow trees. The deposits of sand and gravel appeared to be caused from runoff from the road crossing.
