## Dargues Gold Mine Aquatic Ecology Monitoring Autumn 2024

Final report to the Aurelia Metals Ltd  
Centre for Applied Water Science  
University of Canberra

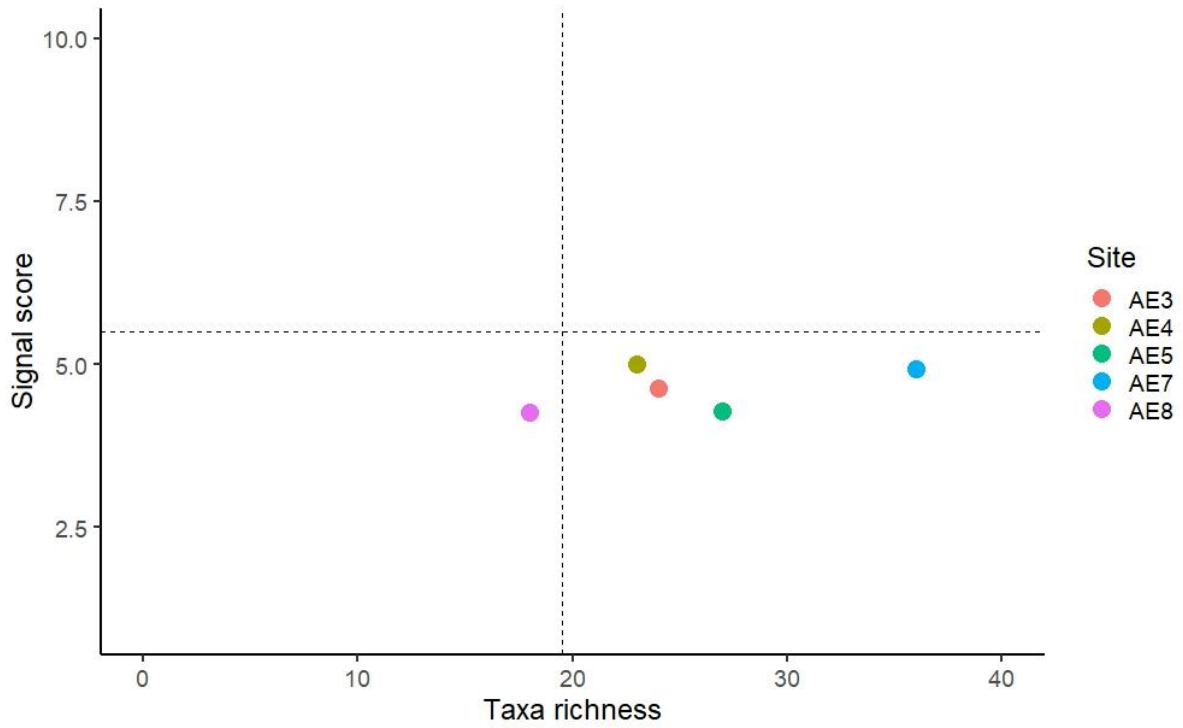
Figure 3. Biplot of macroinvertebrate communities collected from edge samples in autumn 2024. Dotted lines indicate the location of quadrants for interpretation of site SIGNAL results (from Chessman 2001).

The average SIGNAL scores for each site ranged from 4.37 at AE8 to 6.33 at AE2 in autumn 2024 (Table 5). AE8 had the lowest site SIGNAL score and AE3 (edge) had lowest proportion of sensitive taxa (Table 5). For edge communities, site SIGNAL scores at reference sites were 4.27 – 4.93, indicating moderate pollution to mild pollution, respectively. For the impacted sites (AE3 – AE5) the site SIGNAL scores ranged between 4.28 – 5.0 for edge communities, indicating moderate pollution. Riffle habitats had higher site SIGNAL scores than edge habitats with scores ranging from 5.8 – 6.63 (Table 5). All sites where edge samples were collected had site SIGNAL scores ranging from 4.27 – 5.0 (Table 5). Two sites, AE3 and AE7, were assessed as being in the same condition quadrant (Quadrant 2: community impairment, often caused by high salinity or nutrient levels) as they were in the spring 2023 sampling (Figure 3). Site AE4, AE5 increased in condition from Quadrant 4 (urban, industrial, or agricultural pollution, or downstream effects of dams) in spring 2023 to Quadrant 2 in autumn 2024. AE8 remained in Quadrant 4 (urban, industrial, or agricultural pollution, or downstream effects of dams) for the autumn 2024 assessment (Figure 3). There was no significant difference in the macroinvertebrate communities between sites upstream of the mine and sites downstream of the mine, based on samples collected from edge habitats (Global R = -0.1667,  $p = 0.700$ ) (Figure 4).

Macroinvertebrate communities did not significantly differ above and below the DGM. Two of the five edge habitat communities collected remained in the same condition quadrant (Quadrant 2) as they were in spring 2023 (AE3 and AE7) which showed some impairment, and grouped out as sites that are often impaired by salinity or nutrient levels (Chessman 2001). Site AE4 and AE5 increased in condition from Quadrant 4 (urban, industrial, or agricultural pollution, or downstream effects of dams) in spring 2023 to Quadrant 2 in autumn 2024. AE8 remained in Quadrant 4 (urban, industrial, or agricultural pollution, or downstream effects of dams) for the autumn 2024 assessment (Chessman 2001). Overall, macroinvertebrate community health had improved between spring 2023 and autumn 2024. Although total number of taxa decreased, taxa richness from edge samples increased at three of five sites and the percentage of sensitive taxa also increased at three sites ranging from 24 – 33% increase when compared to spring 2023 (Clear *et al.* 2023).

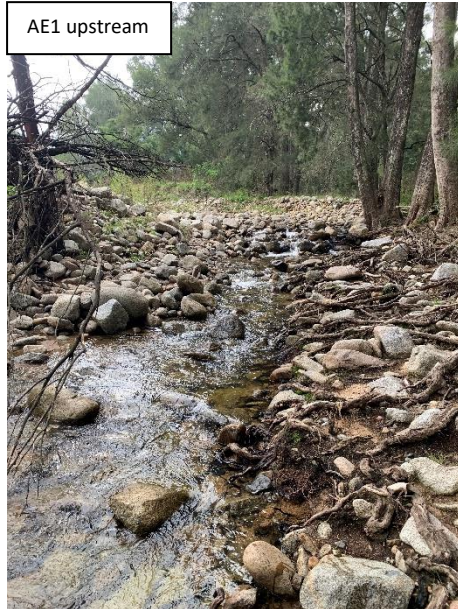
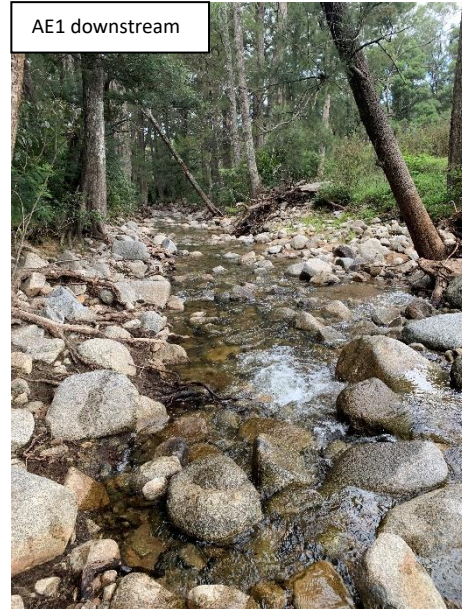
### Site AE1

This site is 5 km downstream of Dargues gold mine near Araluen. It is sparsely vegetated with both native and exotic species.

The channel bed consists of cobbles and boulders embedded in sand and gravel. The water was clear and low at the time of sampling. Riffles were present linking the pools. There was a large amount of sand present filling in the interstitial spaces as a result from recent heavy rains and subsequent high flows. There was little to no detritus present.

The trees and shrubs in the riparian corridor along the stream were mostly native with casuarina being the dominant species.

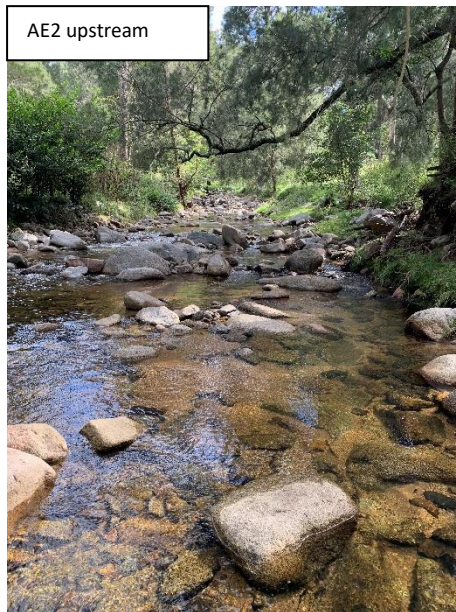
## Site AE2

This site is 400m upstream of AE1 and downstream of Dargues gold mine. The surrounding land and vegetation are the same as AE1.

The channel bed consists of cobbles and boulders embedded in sand and gravel. The water was clear and low at the time of sampling. Riffles were present linking the pools. There was a large amount of sand present filling in the interstitial spaces as a result from recent heavy rains and subsequent high flows. There was little to no detritus present. The banks had undercutting due to the floods from the previous two years which exposed the roots of large trees making them unstable. Dead trees were common with several falling into the river or along the banks.

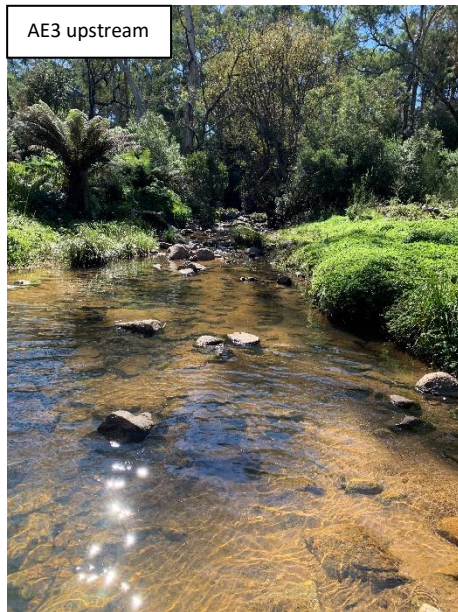
## Site AE3

This site is on Majors Creek, 300 m from the top of Majors Creek Falls and 900 m downstream from the mine. The riparian zone consisted of a mix of native and exotic species while the broader area outside of this was mostly undisturbed native vegetation.

The channel frequently alternated between riffles and pools and consisted of bedrock with cobbles and boulders. Bars of sand and silt were common, and the bottom was heavily silted and covered in sand from recent high flows. Bank undercutting was frequent along the stream and the banks were mainly held by ferns and grasses.

The water was clear and low flowing at the time of sampling. No macrophytes was present at the time of sampling.

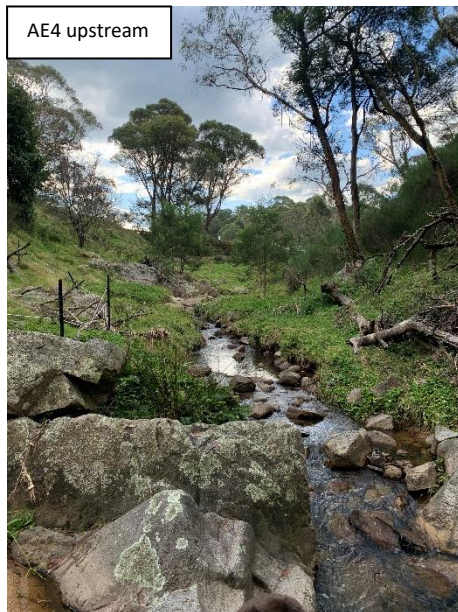
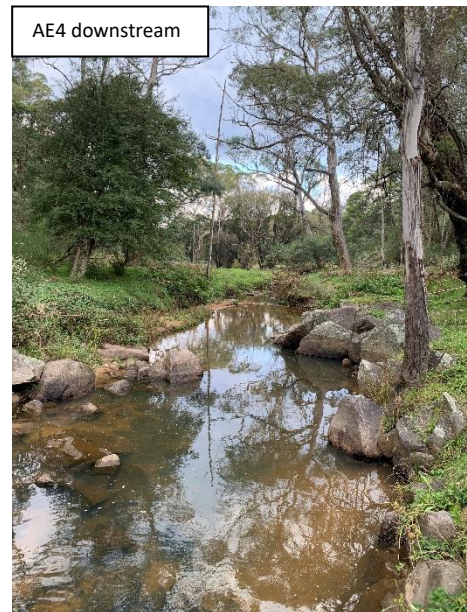
## Site AE4

This site is 400m downstream of Majors Creek Road. The riparian zone consisted of mixed native and exotic trees and shrubs while the broader area consisted mixed native vegetation, pastures and exotics.

The channel consisted of long pools and runs with infrequent riffles. Many large boulders were present and bars of sand and silt were common and the bottom was mainly covered with sand from recent high flows. Bank undercutting was frequent along the stream the banks were held by grasses and sedges.

The water was clear and low flowing at the time of sampling. No macrophytes were present at the time of sampling.

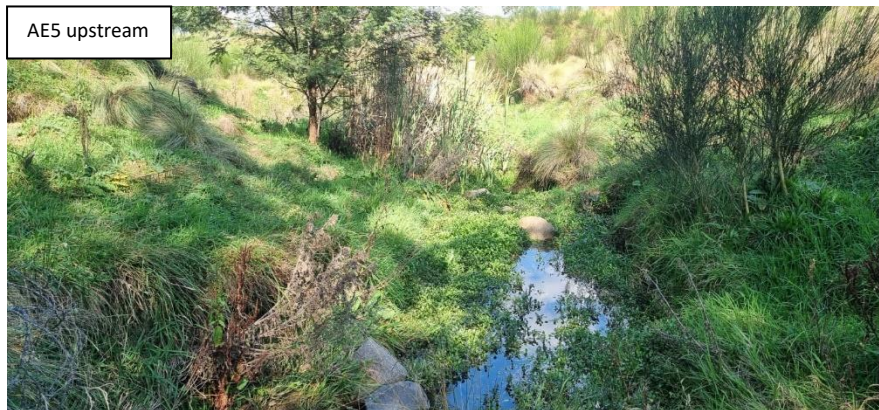
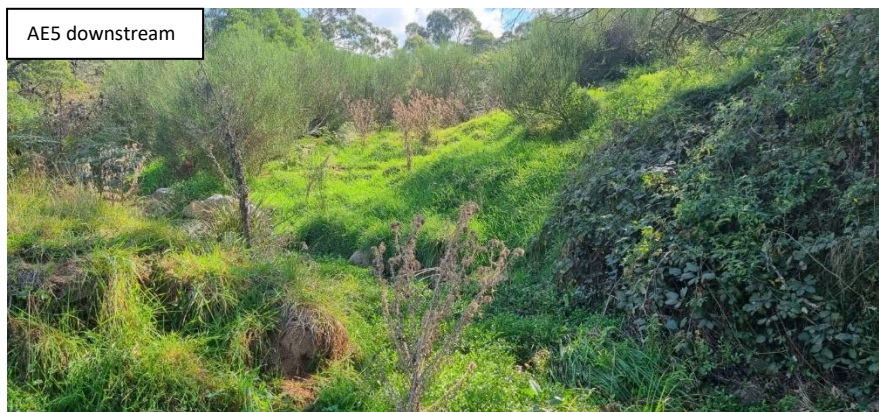
## Site AE5

This site is on Spring Creek and downstream of Dargues goldmine project area. The riparian zone is made of mostly grasses and herbs (exotic and native) which supported both banks. The broader area consisted of mainly pasture with scattered trees.

The channel consists of narrow runs and occasional pools. The creek bed consists of cobbles and boulders with bars of sand and silt common. Bank undercutting was frequent along all parts of the creek.

The water at the time of sampling was clear and low flowing. Submerged and emergent macrophytes were present within the reach and covered the creek in parts making it impossible to sample some sections.

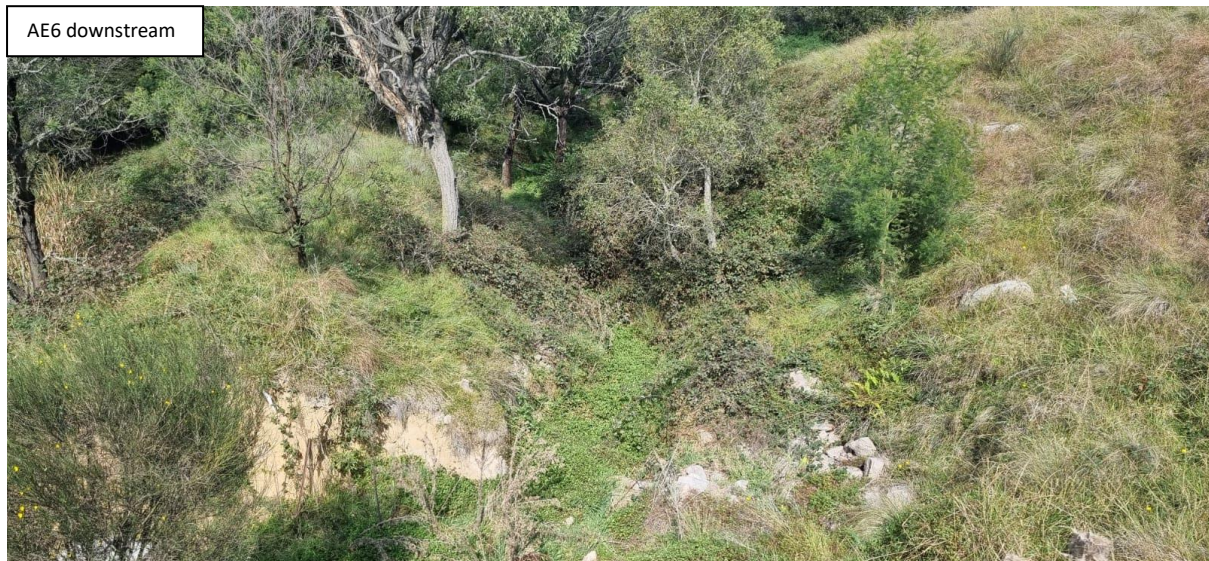
## Site AE6

This site is on Spring Creek upstream of Dargues gold mine and approximately 700m upstream of AE4. The survey area is immediately downstream of the haul road crossing. The riparian zone consisted of pasture grasses and with minimal trees and was overgrown with blackberries.

The channel consists of narrow runs and occasional pools. Cobbles and boulders were present with the benthic composition being sand and silt.

The water at the time of sampling was clear and extremely low. Submerged and emergent macrophytes along with algae dominated the reach at the time of sampling. This with the low flow made it impossible to sample.

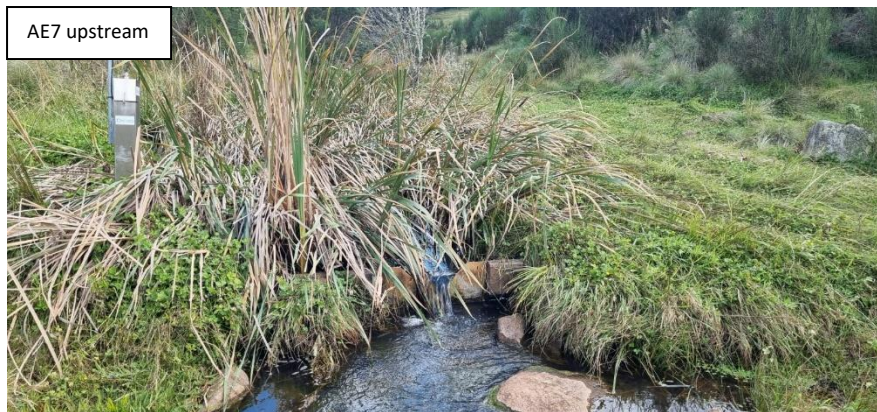
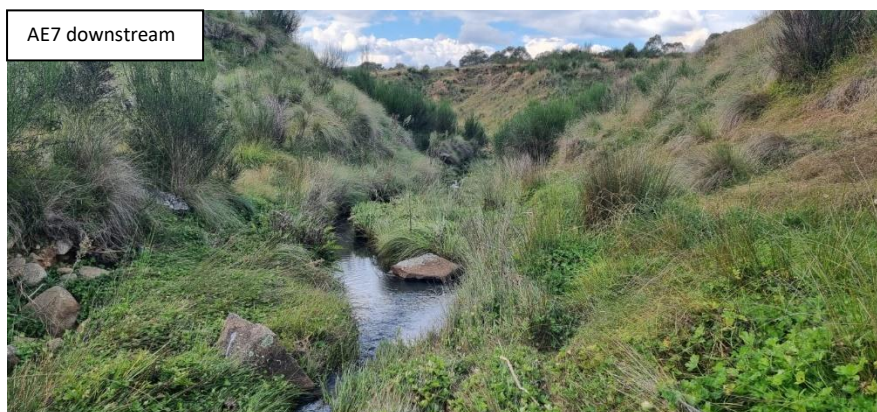
## Site AE7

This site is on Majors Creek approximately 1 km upstream from the confluence with Spring Creek. As it is upstream of the gold mine it acts as a reference site as there are no potential influences from the mine. The riparian zone consisted of shrubs and grasses that overhung the water on both banks with no mature trees present. The vegetation in the broader area was similar to the riparian zone.

The channel consisted of runs and pools with no riffles. The creek bed consisted of sand and silt with boulders and shallow bedrock.

The water was clear at the time of sampling. Woody debris was common throughout the reach and the pool upstream of the weir was dominated by emergent macrophytes. There was little to no algal growth at the time of sampling.

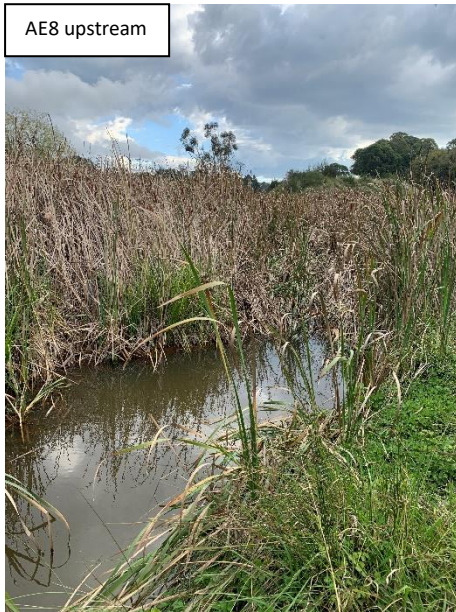
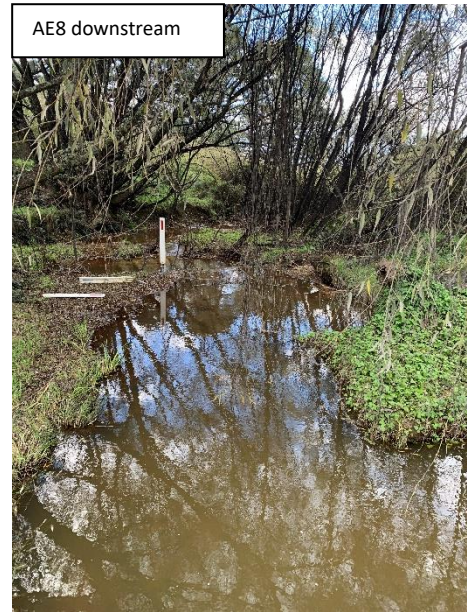
## Site AE8

This site is on Majors Creek, north of the Majors Creek village and is divided by a road causeway. Like AE7 it acts as a reference site as its upstream of any potential impacts from the mine. The riparian zone was dominated by exotic trees and shrubs in particular willows and blackberries. The broader area has been cleared and consisted mostly of grasses.

The channel consisted of a pool upstream of the causeway and shallow runs downstream. The creek bed consisted of soft sediment and some woody debris consisting of fallen willow and willow roots.

The water was slightly turbid and iron flocs occurred on the edges of the creek. The pool upstream was heavily lined with emergent macrophytes and downstream was choked with juvenile willow trees. The deposits of sand and gravel appeared to be caused from runoff from the road crossing.
