Dargues Gold Mine Aquatic Ecology Monitoring Autumn 2025

Final report to the Aurelia Metals Ltd
Centre for Applied Water Science
University of Canberra

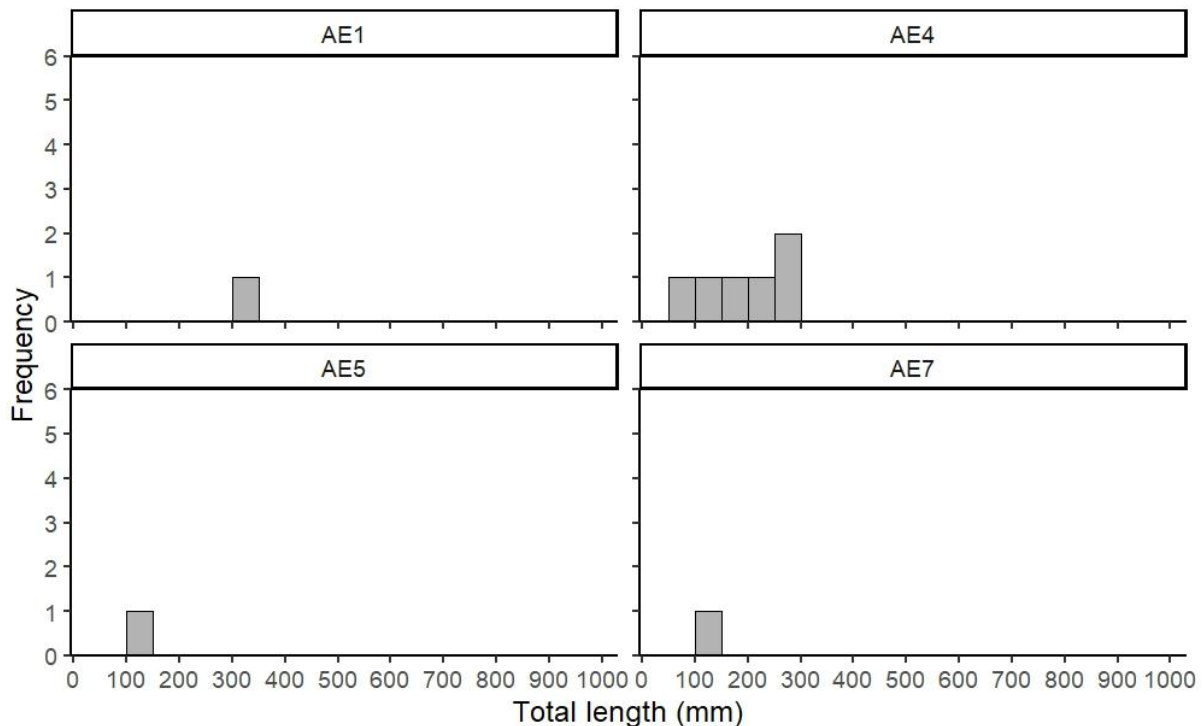
Figure 6. Length frequency of Short-finned eel captured by backpack electrofishing at four sites in autumn 2025.

Nine Short-finned eels were captured across four sites ranging in size from 100 – 350 mm total length (TL) (Table 7 and Figure 6). The most widespread species were Mountain galaxias captured at five out of eight sites (Table 7). Mountain galaxias were also the most abundant species with 265 individuals (comprising 83 % of total number of fish captured) captured ranging in size from 34 – 90 mm fork length (FL) (Table 7 and Figure 7). A total of 44 Cox's gudgeon were caught at sites AE1 and AE2 and ranged in size from 40 – 90 mm (TL) and were the second most abundant species captured (Table 7 and Figure 8). Two Long-finned eels were captured at site AE1 and AE4 and measured 300 and 200mm (TL), respectively.

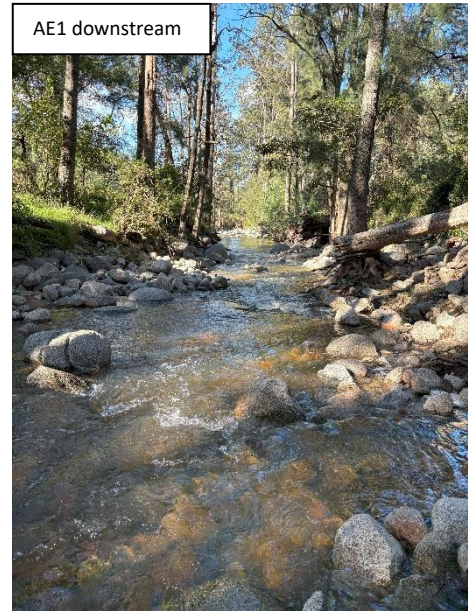
Site AE1

This site is 5 km downstream of Dargues gold mine near Araluen. It is sparsely vegetated with both native and exotic species.

The channel bed consists of cobbles and boulders embedded in sand and gravel. The water was turbid with an increased flow at the time of sampling because of recent rainfall. Riffles were present linking the pools. There was sand present in the slower flowing sections and no detritus present as it would have been washed away by the elevated flows.

The trees and shrubs in the riparian corridor along the stream were mostly native with casuarina being the dominant species.

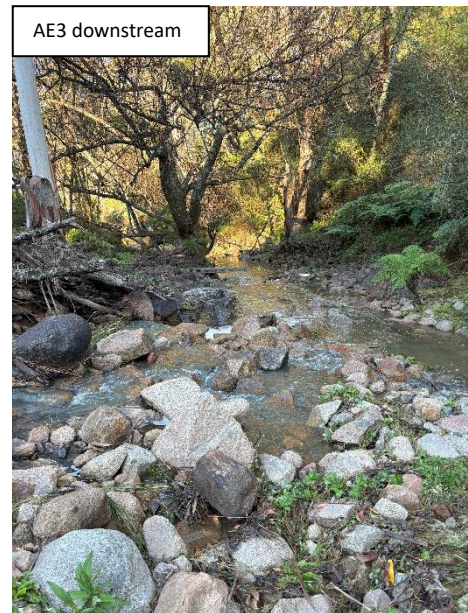
Site AE3

This site is on Majors Creek, 300 m from the top of Majors Creek Falls and 900 m downstream from the mine. The riparian zone consisted of a mix of native and exotic species while the broader area outside of this was mostly undisturbed native vegetation.

The channel frequently alternated between riffles and pools and consisted of bedrock with cobbles and boulders. Bars of sand and silt were common covering the stream bottom in the pools and slower flowing areas. Bank undercutting was frequent along the stream and the banks were mainly held by ferns and grasses.

The water was turbid with an increased flow at the time of sampling because of recent rainfall. No macrophytes were present at the time of sampling.

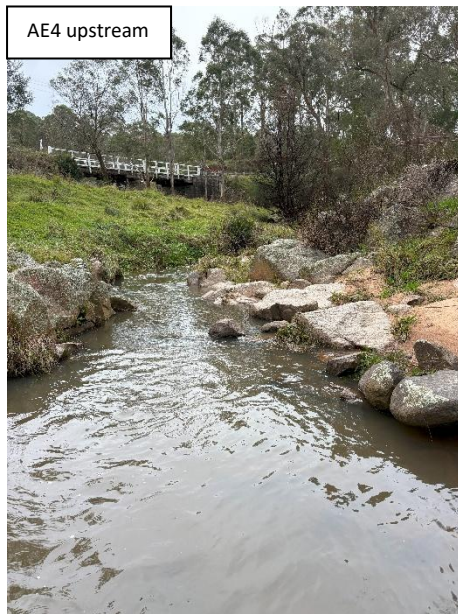
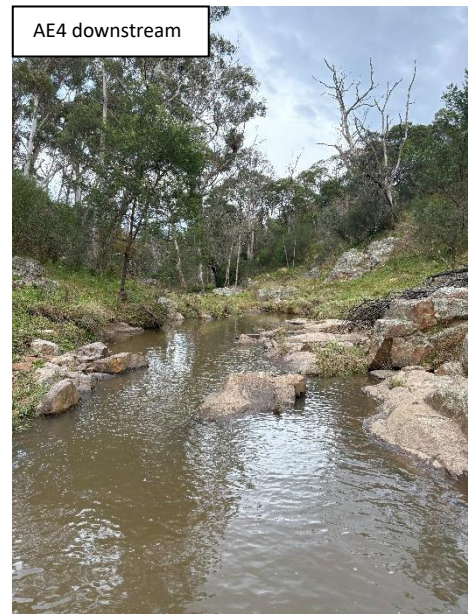
Site AE4

This site is 400m downstream of Majors Creek Road. The riparian zone consisted of mixed native and exotic trees and shrubs while the broader area consisted mixed native vegetation, pastures and exotics.

The channel consisted of long pools and runs with infrequent riffles. Many large boulders were present and bars of sand and silt were common covering the stream bottom in the slower flowing sections of this reach. Bank undercutting was frequent along the stream the banks were held by grasses and sedges.

The water was turbid with an increased flow at the time of sampling because of recent rainfall. No macrophytes were present at the time of sampling.

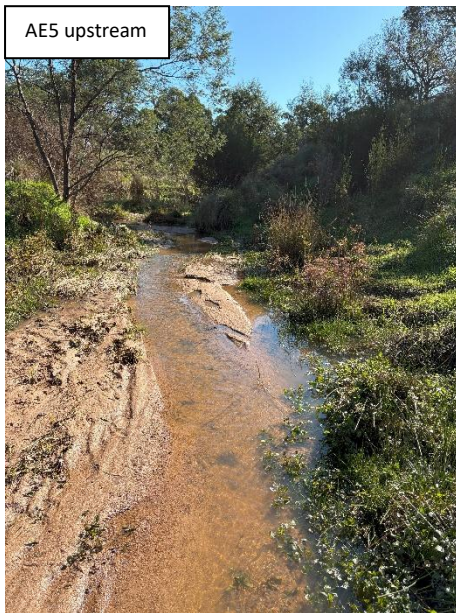
Site AE5

This site is on Spring Creek and downstream of Dargues goldmine project area. The riparian zone is made of mostly grasses and herbs (exotic and native) which supported both banks. The broader area consisted of mainly pasture with scattered trees.

The channel consists of narrow runs and occasional pools. The creek bed consists of cobbles and boulders with bars of sand and silt common. Bank undercutting was frequent along all parts of the creek.

The water was turbid at the time of sampling because of recent rainfall. Submerged and emergent macrophytes were present within the reach. The emergent macrophytes had been pushed over due to recent heavy flows. There was also an increase in the amount of sand deposited in the slower flowing sections because of the heavy flows from the recent rainfall. Some sections are still covered with overhanging vegetation and emergent macrophytes making it impossible to sample.

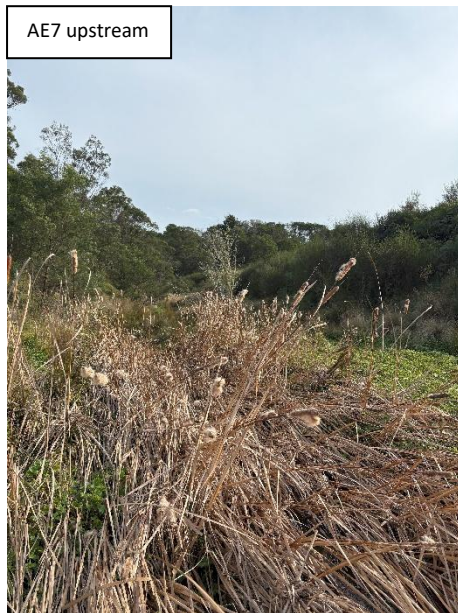
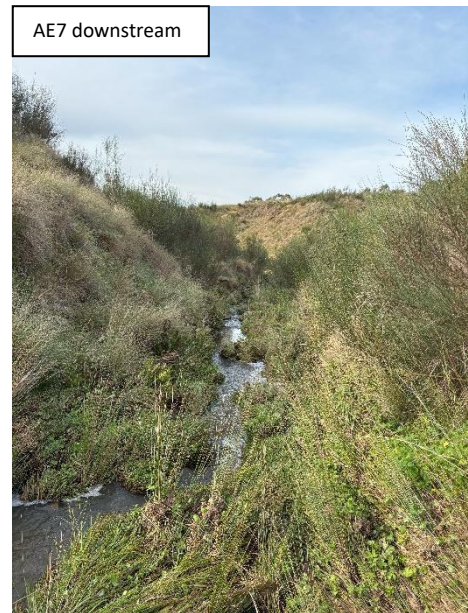
Site AE7

This site is on Majors Creek approximately 1 km upstream from the confluence with Spring Creek. As it is upstream of the gold mine it acts as a reference site as there are no potential influences from the mine. The riparian zone consisted of shrubs and grasses that overhung the water on both banks with no mature trees present. The vegetation in the broader area was similar to the riparian zone.

The channel consisted of runs and pools with no riffles. The creek bed consisted of sand with boulders and shallow bedrock.

The water was turbid at the time of sampling because of recent rainfall. Woody debris was common throughout the reach and the pool upstream of the weir was dominated by emergent macrophytes that were laying over at the time of sampling because of recent heavy flows. There was little to no algal growth at the time of sampling.

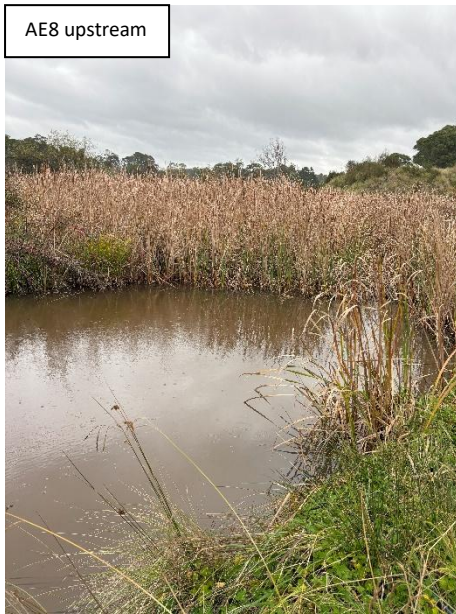
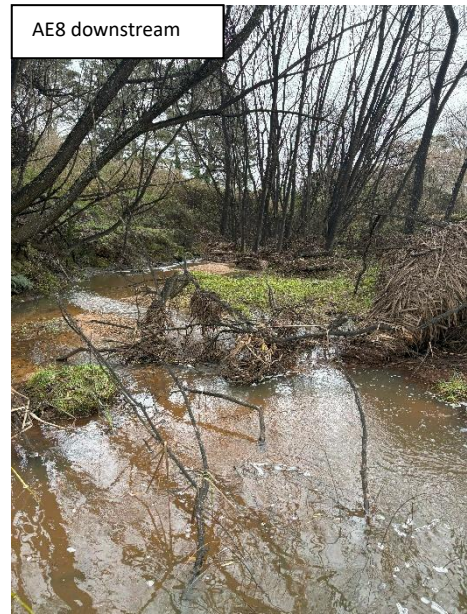
Site AE8

This site is on Majors Creek, north of the Majors Creek village and is divided by a road causeway. Like AE7 it acts as a reference site as its upstream of any potential impacts from the mine. The riparian zone was dominated by exotic trees and shrubs in particular willows and blackberries. The broader area has been cleared and consisted mostly of grasses.

The channel consisted of a pool upstream of the causeway and shallow runs downstream. The creek bed consisted of soft sediment and some woody debris consisting of fallen willow and willow roots.

The water was turbid with elevated flows at the time of sampling because of recent rainfall. The macrophytes had recovered in the pool upstream when compared to the spring 2024 sampling. Downstream was choked with juvenile willow trees. The deposits of sand and gravel appeared to be caused from runoff from the road crossing.
