# Peak Gold Mines MONTHLY ENVIRONMENTAL MONITORING SUMMARY REPORT

EPL 3596 Hillston Road, Cobar NSW 2835

**November 2020**

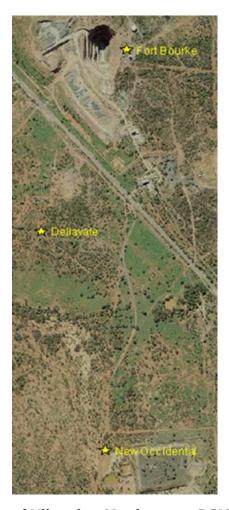
Figure 1: Location of Vibration Monitors on PGM's Mining Leases.

The vibration monitoring results displayed in Table 4.1a represents all blast vibration events that were trigged at the New Occidental, Fort Bourke and/or Dellavale monitors (Figure 1).

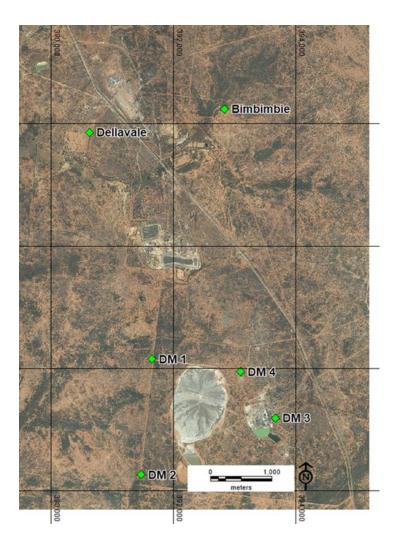
Figure 2: Location of dust gauges on PGM Mining Leases.

Fall out dust deposition bottles are currently used to monitor air quality. The bottles are positioned in the field (Figure 2) for a period of  $30 \pm 2$  days. Monitoring is undertaken quarterly. The bottles are then sent to Australian Laboratory Services (ALS) for external analysis.

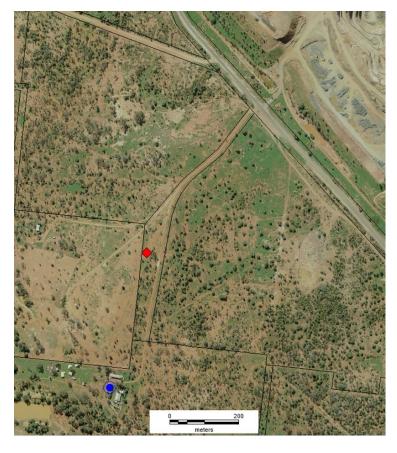
Figure 3: Location of the "Dellavale" properties house (blue circle) and noise monitoring location (red diamond).

A hand-held monitor is used by PGM employees to monitor noise levels at times set out by the EPL and development consent conditions. Noise monitoring is conducted at the closest resident (figure 3) and sporadically depending on operational requirements. PGMs closest monitoring point is located at the Dellavale boundary, approximately 400m closer to the mine noise than the residence. To determine the noise level (dB) experienced at the residence, sound intensity I and the inverse square law  $1/r^2$  is calculated based on the residences distance from mine noise source.

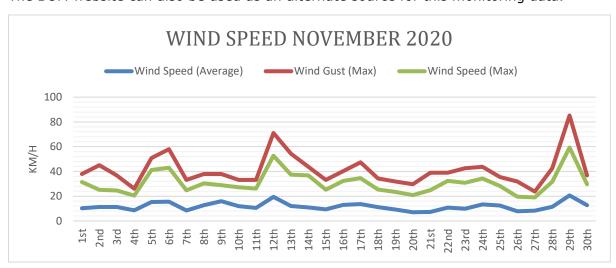
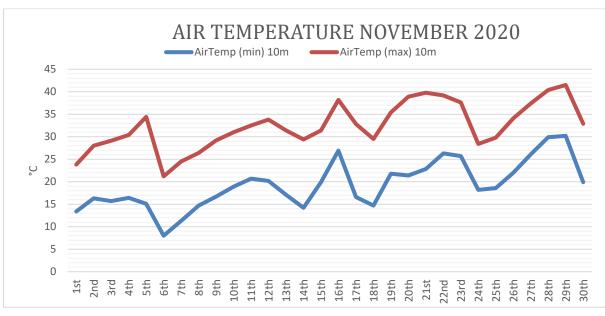
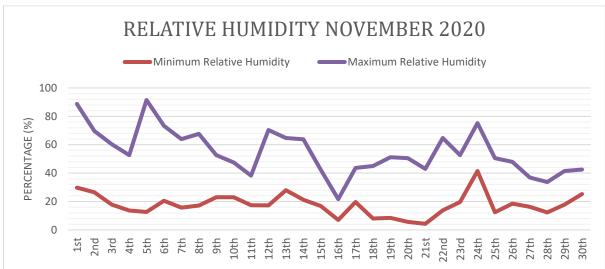
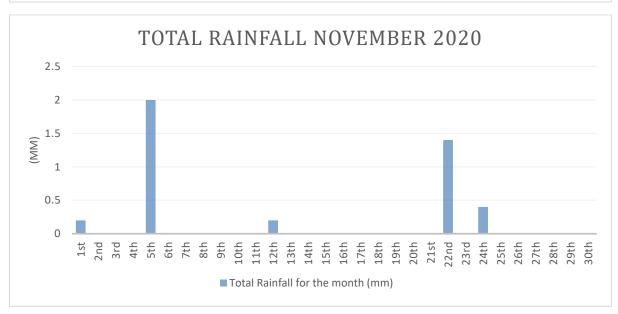
The meteorology monitoring data is acquired through PGM's weather station located 2km South of Cobar.
